13th World Conference on Earthquake Engineering
Vancouver, B.C., Canada
August 1-6, 2004
Paper No. 2871

Performance of Traditional Arches and Domes in Recent Iranian Earthquakes

T. MAHDI¹

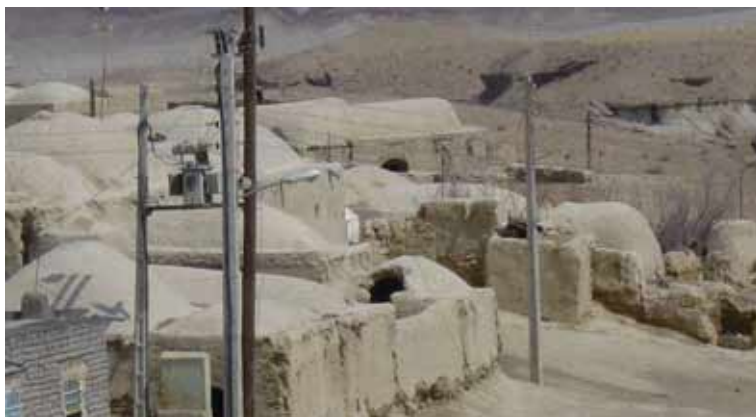
Figure 1: A typical village in eastern Iran with vaulted roofs.

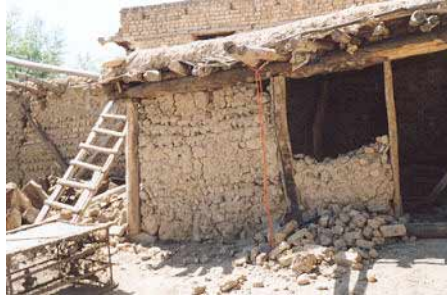
- (3) A system similar to that in (2) but roofs are fixed to wooden columns within the wall. This system has some similarity to the confined masonry wall system, which consists of tie columns and beams. This system has proved its ability to resist earthquakes in the past. As shown in Figure 2, even by using thin irregular members, this system has prevented the collapse of the roof. However, and to have an ideal system, it is quite vital to provide suitable connection details. This system is mostly used in the mountainous areas and in some special buildings in large cities.

Figure 2: A typical traditional building with wooden beams and columns in western Iran after the 2002 Avaj's earthquake.

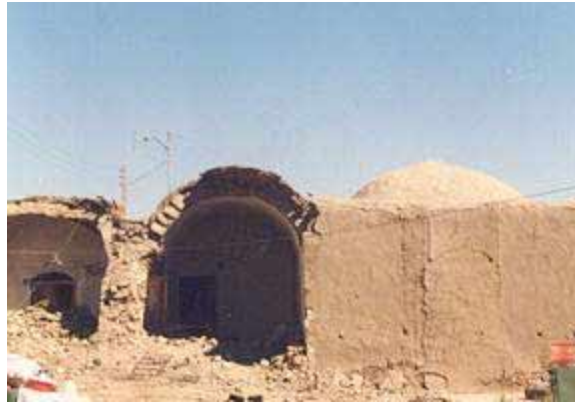
The two main types of vaulted roofs in the earthquake-stricken area were domes and barrel vaults. These roofs are shown in Figure 3. Adobe bricks and mud mortars with thickness not less than 25 cm were used to build the vaulted roofs. In some cases, and as has been reported by Hankuno [5], the thickness of some vaulted roofs were more than one meter. Burned bricks were also used for some vaulted roofs in the area. In a circle of 16 km radius around the village of Ardekul, where the earthquake had its highest intensity, adobe houses with vaulted roofs were also suffered heavy damages. Most of these failures were due to the weakness of wall-to-wall and wall-to-roof connections. However, and as reported by Hakuno [5], some of these buildings had remained stable and the vaulted roofs had not been collapsed. This phenomenon was also observed in other villages in the southern part of the earthquake-stricken area [5].

Some of rural houses in the area had barrel vault roofs. Such a vault is usually restricted to a relatively narrow width as shown in Figure 3. In traditional buildings, and due to the lack of ring beams between roofs and walls, walls carry all vertical and horizontal forces. As the finite element analysis shows, the failure of these types of structures is resulted when excessive displacements perpendicular to the vault generator occurred.

Figure 3: Typical adobe buildings with vaulted roofs in eastern Iran.

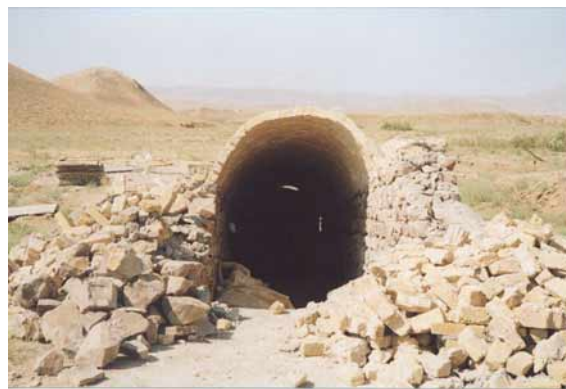
Although most of the buildings in this mountainous area having flat roofs, the existence of masonry buildings with vaulted roofs had also been observed. As an example, Figure 4 shows a brick masonry storage building with vaulted roof that is situated three kilometers from the surface faulting. In this

particular case, the lateral load direction was parallel to its generator (longitudinal direction) and the performance of this roof was excellent. Beside residential and storage buildings, the domes of many mosques, holy shrines, and towers were among the affected buildings by this earthquake.

Figure 4: A masonry barrel vault, 3 km from Avaj's fault, western Iran

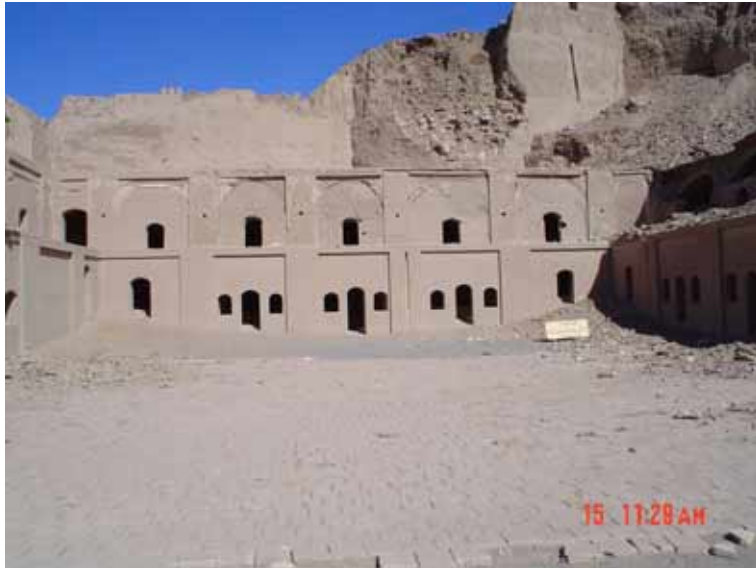
The arch can have many architectural and structural functions. In the traditional Iranian architectural system, arches are used to face the central courtyard of the building, as shown in Figure 5. The small arches shown in this figure is merely a facade that is hiding the real structure behind it and merely worked as a shear wall. For the arches perpendicular to this direction, a complete separation between the facade wall and original structure had occurred, which led to partial failure of these walls as shown in Figure 6. As a structural component, and as shown in Figure 7, arches are used to transfer loads from a dome to its pillars. In this structure, arches of different sizes and shapes have been assembled to fulfill this function. It is clear from this figure that earthquake forces had led to serious sliding and opening of joints in the pillars. This partial failure was caused by the unbalanced thrust transmitted from the adjacent arches. This problem was observed in single-span vaulted roofs as well. To resist the horizontal seismic movement, the joint between the arch and the pillar must be inclined and the pillar must have enough width to keep the

Figure 5: The east-west wall of the Military barrack in Arg-e-Bam.

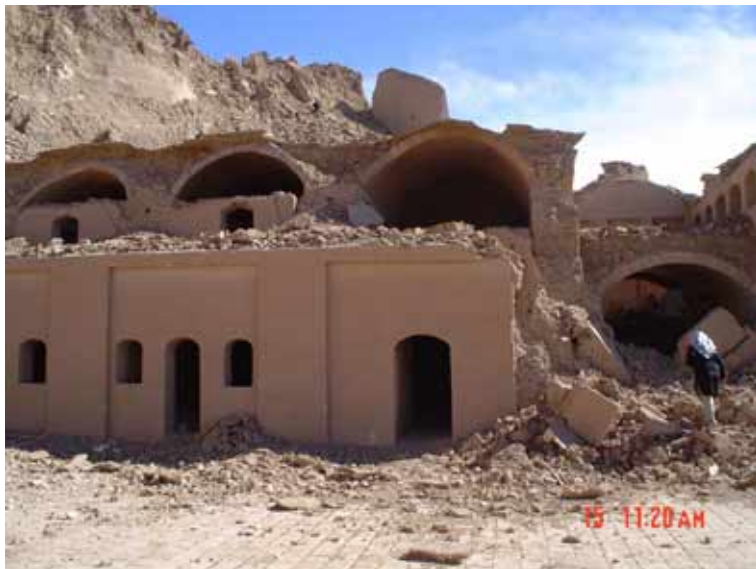
resultant forces within the central part. It is clear from Figure 7 that this later condition has not been met. Many of the buildings that survive the earthquake have successfully fulfilled these rules as shown in Figure 6.

Figure 6: The north-south wall of the military barrack in Arg-e-Bam.

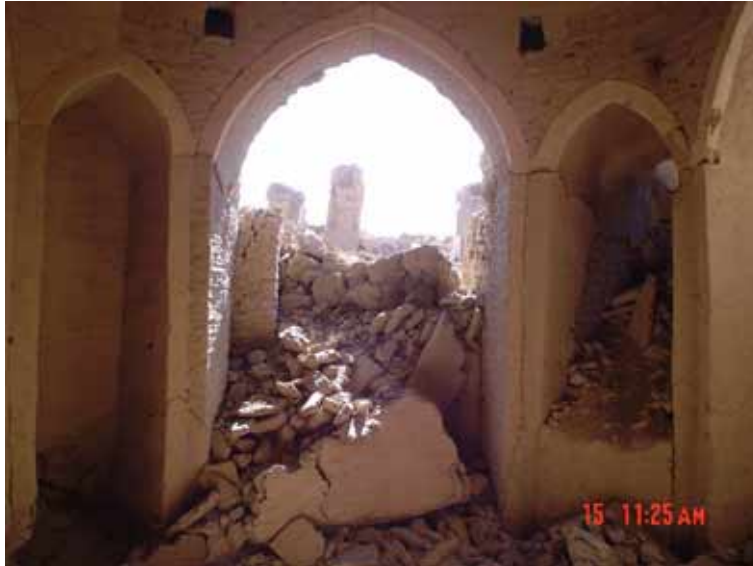
Figure 7: Arches used to transfer loads from a dome to its pillars.

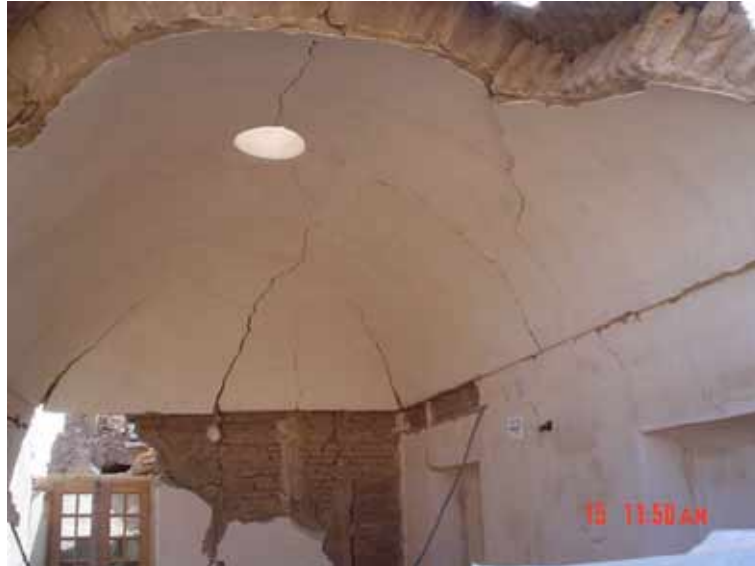
The surviving roofs can be seen all over the city and even at short distance from epicenter. In Arg-e-Bam, many barrel vaults were destroyed in the earthquake. However, others had shown good behavior even when the direction of the movement was perpendicular to their generators. Although it is very difficult to understand the reason of this good behavior, it has been noticed that the thickness of buildings' roofs inside Arg-e-Bam is much less than the corresponding ones inside the city. Other reasons like site effect may also be responsible for this behavior. Figure 8 shows another example of such roofs. It can be seen from this figure that bearing walls had minor cracks compared to those appeared in the roof. The pattern of cracks in the roof indicates clearly that some vertical forces were applied to it. That can be explained by the high vertical acceleration component of this earthquake. Furthermore, some new masonry buildings in the city of Bam had been constructed using barrel vaults as their roofs. These roofs were connected well with the wall by ring beams. With the exception of minor failures and some cracks, these roofs performed satisfactorily. The failures and cracks observed were mostly concentrated at regions in the neighborhood of the intersection line of the barrel vault with the end cap.

Figure 8: A barrel vault with cracks in Arg-e-Bam

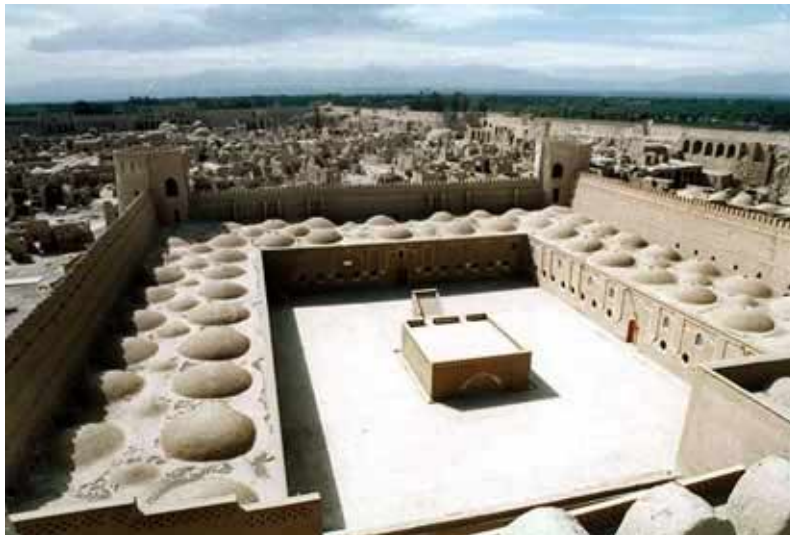
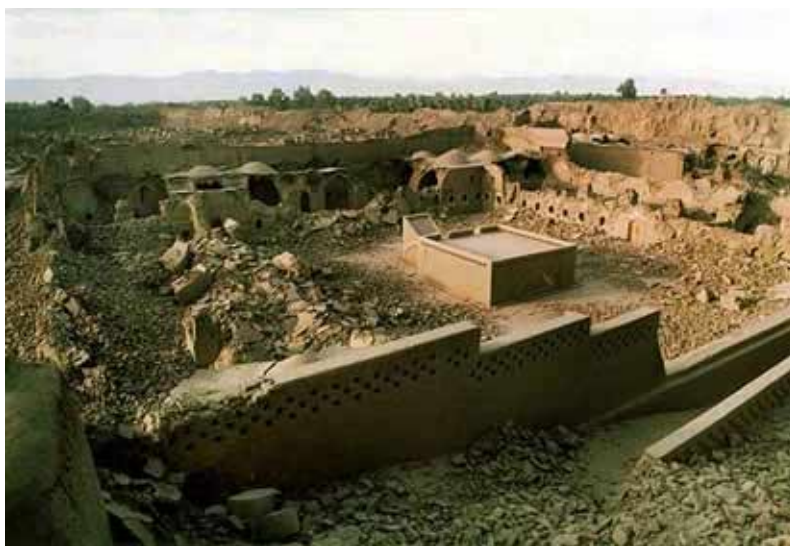
In the majority of cases, a complete destruction of adobe buildings including their domes was observed. An example of such destruction is shown in Figure 9. This figure shows the stable courtyard inside Arg-e-Bam with many surrounding buildings that have a large number of domes, before and after the earthquake. The majority of domes shown in Figure 9a were destroyed completely as shown in Figure 9b. Supporting walls were also destroyed partially or completely. Although such walls had very small openings, it was the normal forces to the wall plane that had caused most damages. However, it is interesting to note that parts of these buildings that are located in the right corner of Figure 9 had survived the earthquake by taking advantage of their adjacency to two relatively rigid walls. In the author's opinion, the reaction applied by these two walls during the earthquake had increased the capacity of these parts to resist vertical forces applied by the vertical acceleration component. Prominent among the surviving domes in Figure 9, are those shown in Figures 10 and 11. The vaulted roof shown in Figure 11 has been used to support some of these domes. In this figure, additional arched panels had been added to this structure in order to relieve the bearing walls from parts of their loads. Accordingly, each dome is supported on two arches and two walls. In Bam's earthquake, the forces applied were perpendicular to the arched panels and parallel to the wall. Arches in this case had fulfilled the role of bracings in inactive walls and distributed the loads between active walls to prevent partial failure. The dome-arched panel system shown in Figure 11 is quite similar to that shown in Figure 10. The direction of movement during this earthquake was also parallel to the walls and perpendicular to the arch panels. As it is clear from Figure 11, one of the arches had suffered minor failures. This failure reflects the disability of the arch panel to transfer forces between active walls.

Figure 9a: A courtyard in Arg-e-Bam before earthquake.

Figure 9b: A courtyard in Arg-e-Bam after earthquake.

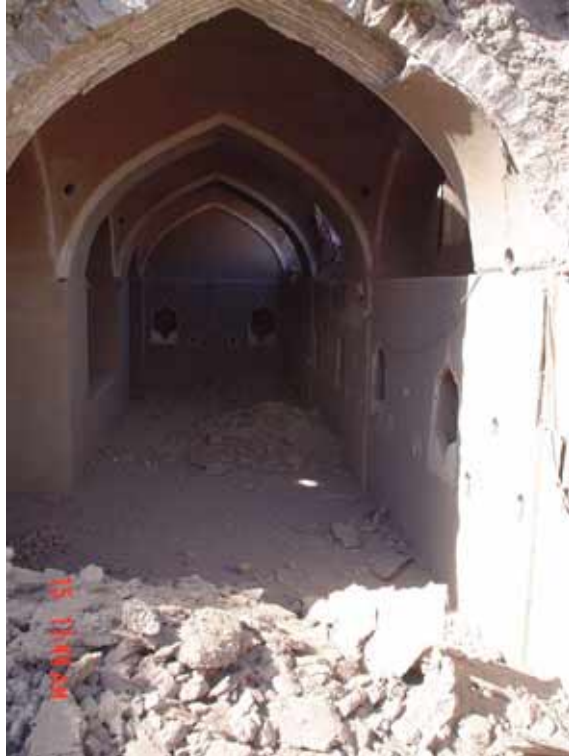
Figure 10: Vaulted roofs with arched panels

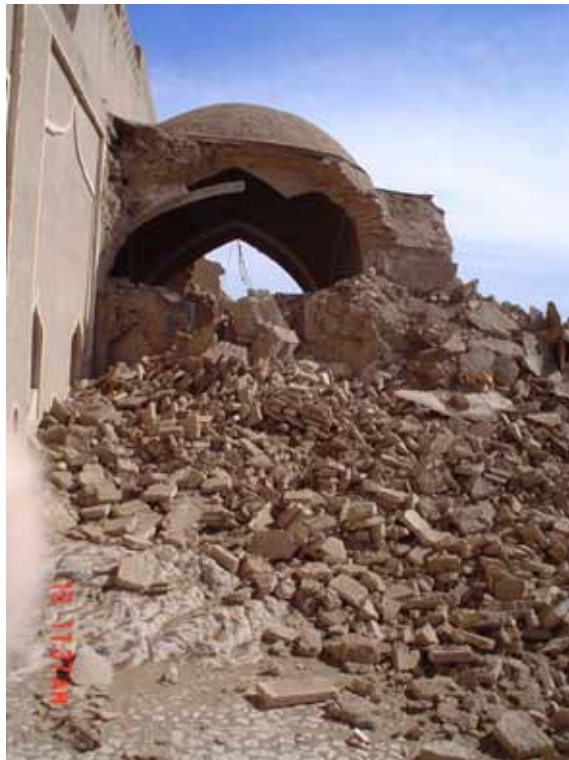
Figure 11: A dome supported by two walls and two arch panels.
